UNITED STATES
DEPARTMENT OF LABOR
MINE SAFETY AND HEALTH ADMINISTRATION
COAL MINE SAFETY AND HEALTH

REPORT OF INVESTIGATION

Fatal Rib Roll Accident
February 1, 2006

#18 Tunnel Mine
Long Branch Energy
Wharton, Boone County, West Virginia
ID No. 46-08305

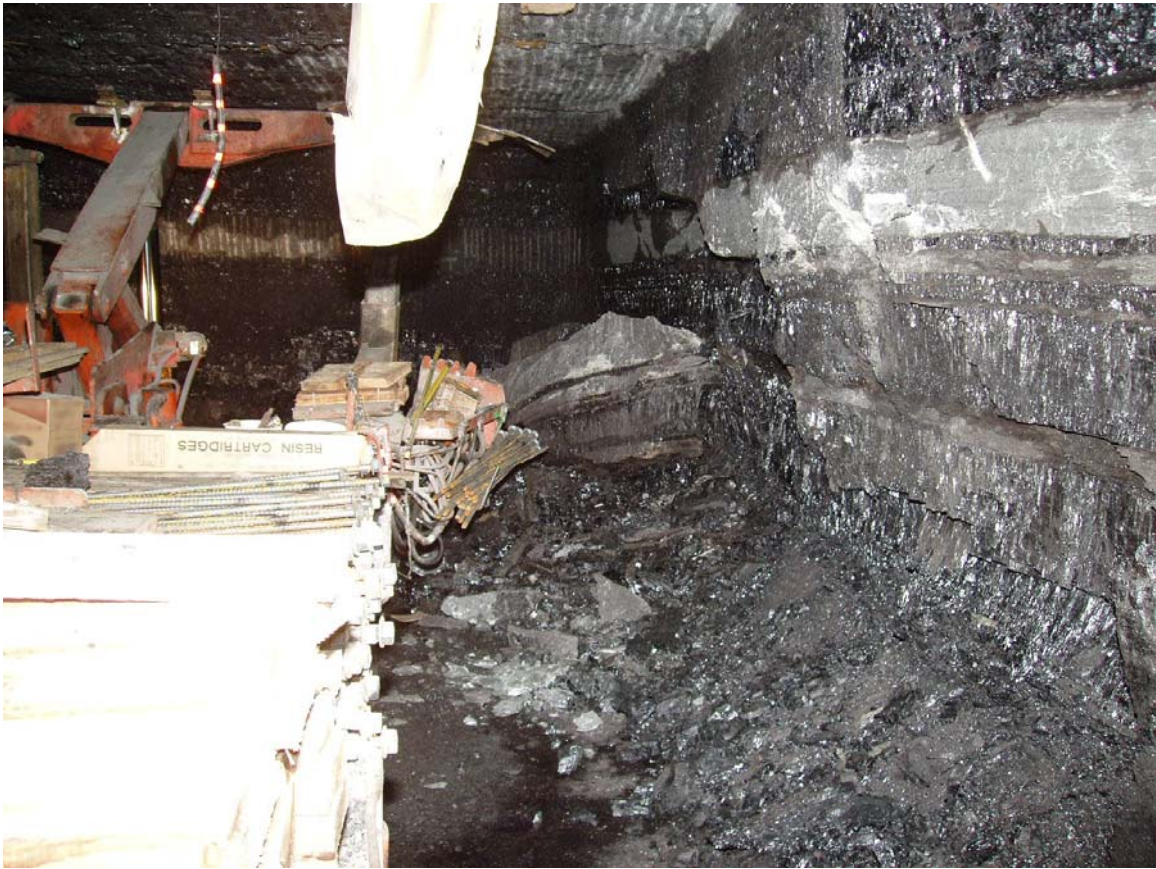
As Timothy Vance and Edmund Vance continued to install the permanent roof support, some rib “popping” near the face was heard. As Timothy Vance was about to begin installing the outer roof bolt, nearest the left rib, a large portion of the right rib fell, pinning Edmund Vance. Timothy Vance ran around the roof bolting machine to help Edmund Vance. Lafferty, whose back was turned to the roof bolting machine as he loaded supplies onto the roof bolting machine, turned and observed the fallen rib material. The fallen rib material had trapped Edmund Vance against the roof bolting machine. Lafferty, Jackson, and Timothy Vance removed the fallen material off of Edmund Vance and administered first aid.

The presence of the thick shale layer near the top of the stratigraphic section made rib conditions particularly hazardous. Coal located beneath the shale layer would slough away from the rib, causing large portions of the shale layer to break away. In other areas of the mine, when the top coal or rider was not present or not mined, the ribs appeared relatively stable.

The rib material which fell from the right rib of the number five entry measured: 13 feet long, 7 to 16 inches thick and 40 inches tall. The material fell from the rib from a height of approximately seven feet. When the rib material began to fall, Edmund Vance was positioned approximately 30 inches from the coal rib.
